# Twin Oaks Home Inspection LLC

Confidential - Property Inspection Report - Confidential

600 Anywhere Road, Somewhere NH, 03333 Inspection prepared for: Name Client Agent: Real Estate Agent -

Inspection Date: 4/1/2010 Time: 5:30 pm Age: 1988 Size: Approx 2,400 Sq Ft Weather: Dry

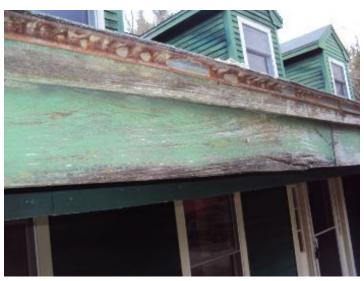
Exposed wood surfaces observed. Wood rot & deterioration can occur. Prep, prime and paint wood trim surface where paint is peeling or missing.

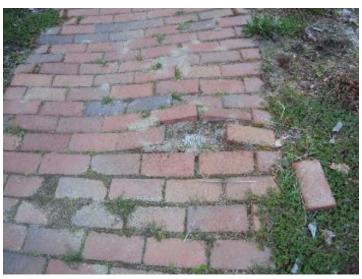
Uneven areas, potential trip hazards

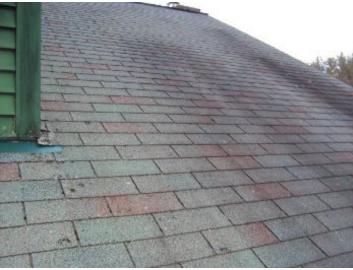
The roof covering is at the end of its life. Replacement should be planned within the next 2-3 years.

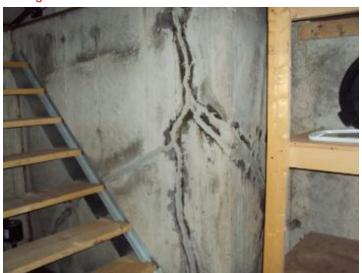
Area of major repair noted to poured concrete foundation wall. This repair appears to be professionally done. Buyer is recommended to request and review any existing documents relative to this repair to determine if any warranties exist. No warranty for this or any other repair is implied by this inspection.

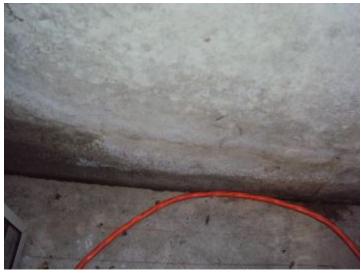
Copper fuel line is in contact with concrete. Risk of corrosion and pitting resulting in fuel line leaks.

Recommend protecting fuel line or replacement.

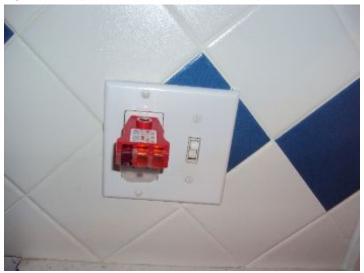
The GFCI in kitchen did not trip properly. This is a safety concern as the GFCI is designed to trip. Recommend repair or replacement of defective GFCI.

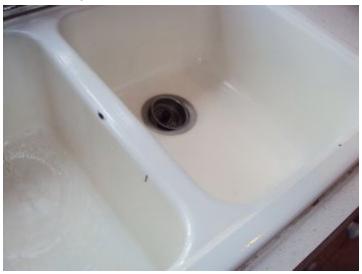
Sink is damaged / cracked

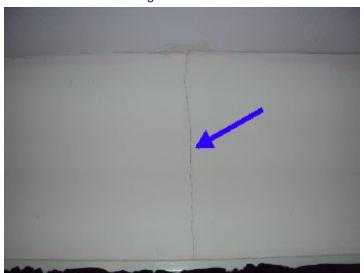
Some cosmetic, common small cracks and typical flaws in drywall finish noted. This is normal wear for age of home.

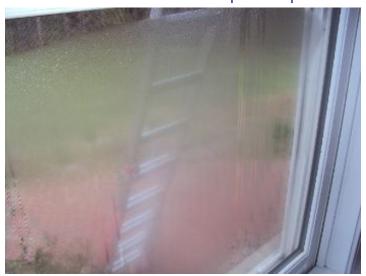
Fog/condensation observed in double glazed windows. This is an indication of a failed seal. Recommend review for repair or replacement as necessary.
